**F8864.01-113-11-R0**  
**ACOUSTICAL PERFORMANCE TEST REPORT**  
**ASTM E90**

**CUSTOM VINYL PRODUCTS, LLC**

**SERIES/MODEL: Veka Series DH55**

**TYPE: Double Hung Window**

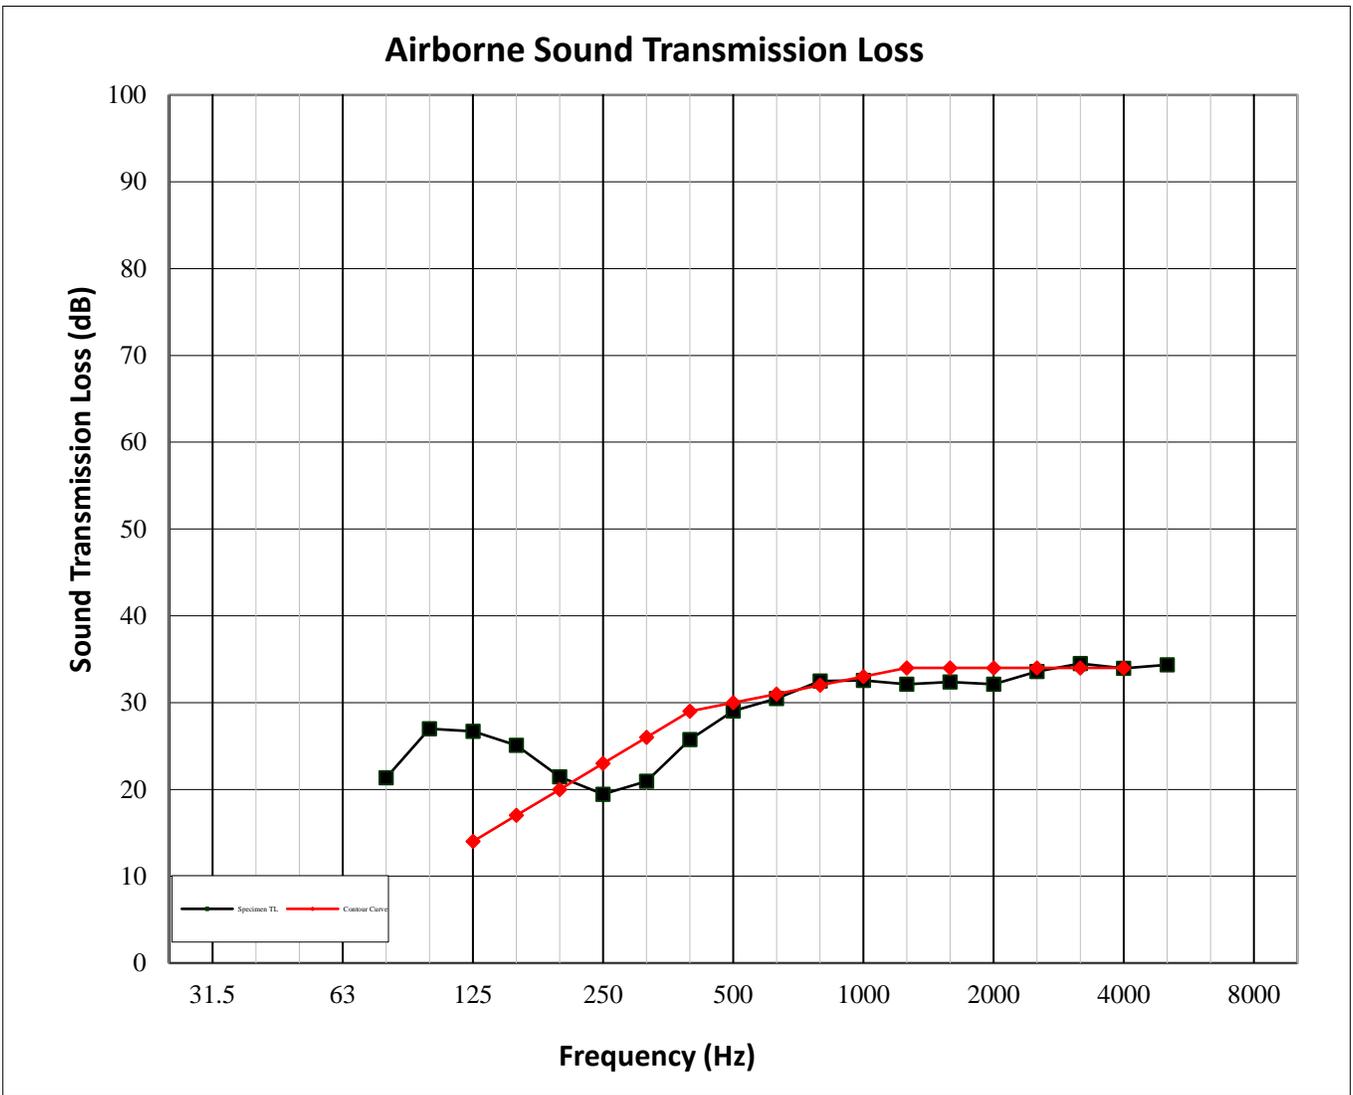
### AIRBORNE SOUND TRANSMISSION LOSS

<b>Test Date</b>	09/22/16					
<b>Data File No.</b>	F8864.01					
<b>Client</b>	Custom Vinyl Products, LLC					
<b>Description</b>	Series/Model: Veka Series DH55, double hung window with 3/4" IG (1/8" annealed exterior, 3/8" air space, 1/4" laminated interior), Glass temperature 75°F					
<b>Specimen Area</b>	1.80 m <sup>2</sup>	Receive Temp.	21.4 °C		Source Temp.	21.3 °C
<b>Technician</b>	Amanda N. Smit	Receive Humidity	51%		Source Humidity	51%

Freq (Hz)	Background SPL (dB)	Absorption (m <sup>2</sup> )	Source SPL (dB)	Receive SPL (dB)	Specimen TL (dB)	95% Confidence Limit	Number of Deficiencies
80	38.1	4.5	104	80	21.3	1.79	-
100	37.2	5.3	104	74	27.0	1.43	-
125	40.6	4.7	103	73	26.7	1.33	0
160	40.7	4.6	103	75	25.1	1.09	0
200	40.5	4.7	105	79	21.5	0.80	0
250	36.4	5.5	105	81	19.4	0.68	4
315	30.3	5.6	98	72	21.0	0.31	5
400	25.7	5.9	95	64	25.8	0.31	3
500	22.0	5.7	95	60	29.0	0.25	1
630	19.3	5.6	99	64	30.5	0.26	1
800	16.7	5.9	99	61	32.5	0.28	0
1000	12.5	6.1	96	58	32.6	0.25	0
1250	10.0	6.6	96	58	32.1	0.23	2
1600	7.7	7.1	101	63	32.4	0.29	2
2000	6.4	7.4	94	56	32.1	0.19	2
2500	6.1	8.4	92	52	33.6	0.27	0
3150	6.5	10.2	94	52	34.5	0.25	0
4000	7.2	12.5	93	50	33.9	0.19	0
5000	8.4	16.0	91	47	34.3	0.29	-

**STC Rating**            **30**            *(Sound Transmission Class)*  
**Deficiencies**        **20**            *(Sum of Deficiencies)*  
**OITC Rating**        **27**            *(Outdoor-Indoor Transmission Class)*

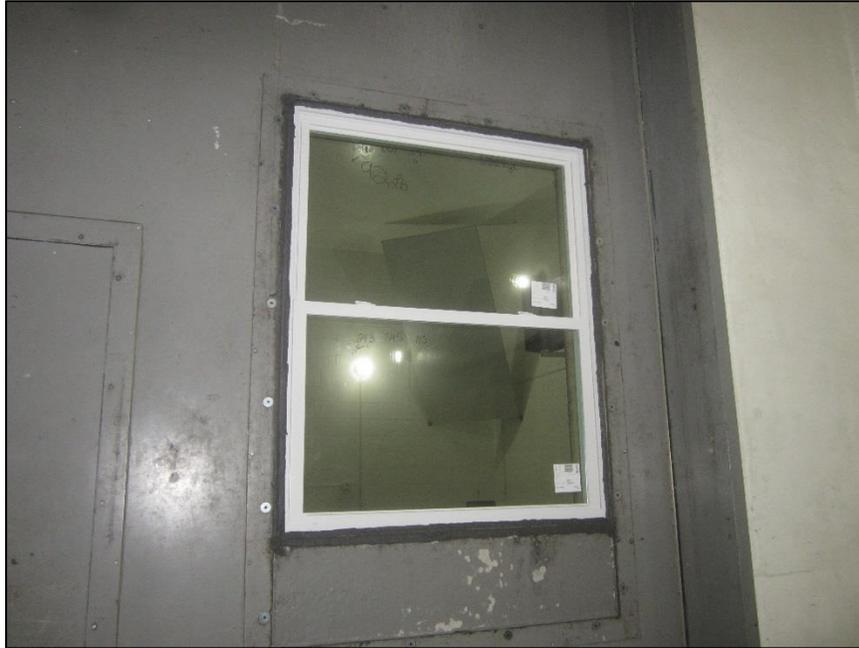
**Receive Room View of Installed Specimen**

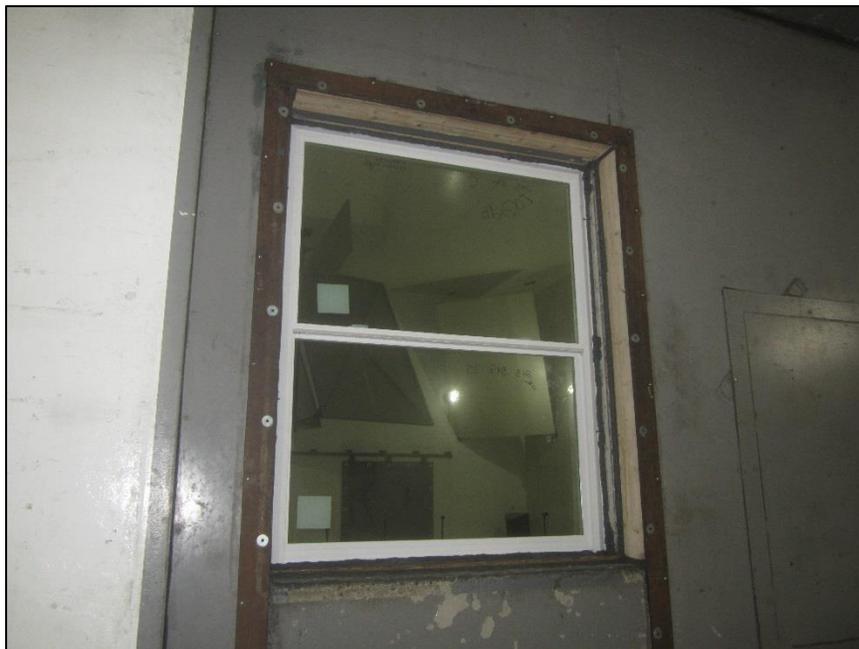
**Source Room View of Installed Specimen**
