Model 288 Push Piers

Project: Affinity Health Group
Location: Menasha, WI
Date: May 2009

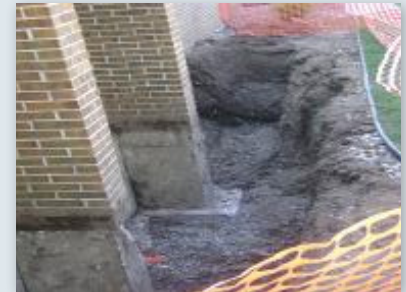
Foundation excavated

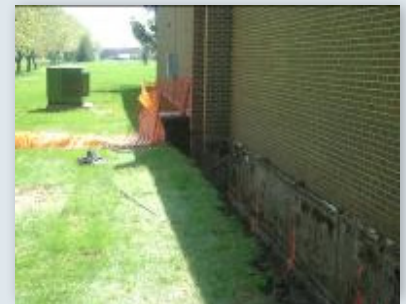
Pier locations marked

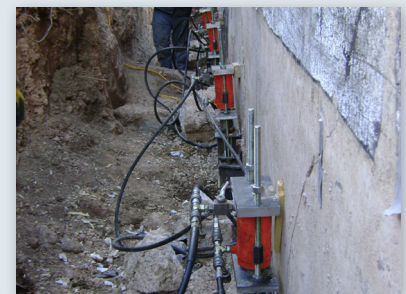
Piers driven to stable soils
