FSI NEWSLETTER FOR DESIGN PROFESSIONALS

DESIGN CONSIDERATIONS

Kyle Olson, P.E. • Senior Structural Engineer

FSI NEWSLETTER FOR DESIGN PROFESSIONALS
Quarterly Newsletter • Issue 12
Summer 2012

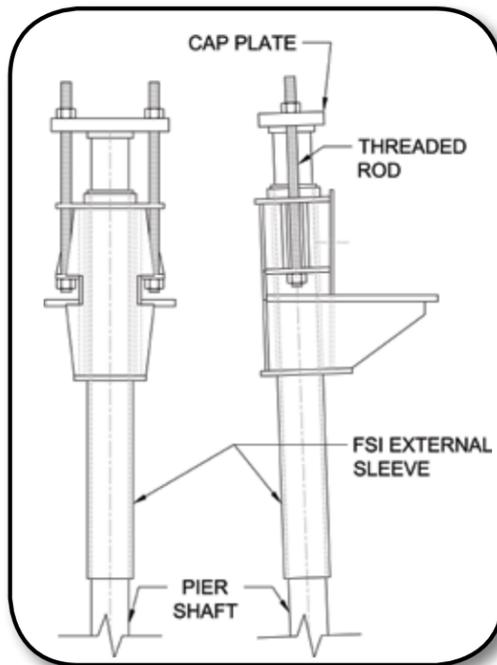
Figure 3: Retrofit Bracket Detail

bracket to essentially create a bracket that is 30 inches tall (Figure 3). Since the external sleeve and the pier shaft are confined by the earth, the bending moment dissipates quickly into the surrounding soils and generally within the first few feet (Figure 4). The depth at which the bending moment dissipates is a function of the soil strength and is greater in soft soils and less in stiff soils. With the external sleeve

Foundation Supportworks addresses the issue of retrofit helical pier eccentricities in one of two ways. The first is to increase the stiffness of the pier system itself, allowing it to resist more of the eccentricity. This is accomplished by incorporating an external sleeve to resist the bending forces. The external sleeve extends through and below the foundation

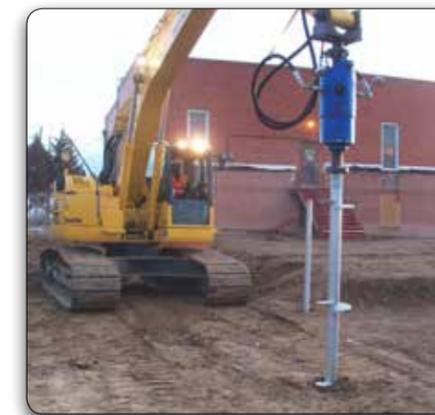
Issue 8 (Summer 2011) of this newsletter presented three ways to predict helical pier capacity with respect to the soil; i.e., individual bearing, cylindrical shear and torque correlation methods. These methods are appropriate for both new construction and retrofit applications. Although soil capacity typically governs the design for new construction helical piers, the allowable mechanical capacity of the retrofit pier "system," which includes the pier, bracket and the concrete foundation, may govern in higher-strength soil conditions.

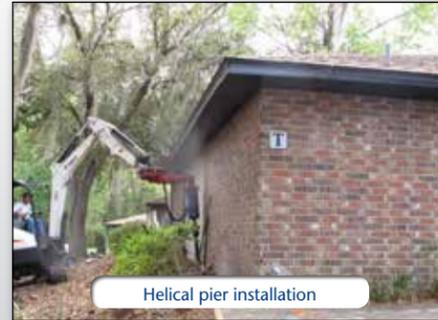
Helical pier installation

Solution: The project geotechnical engineer recommended that the exterior foundations be supported with retrofit helical piers and the interior floor slabs be supported with hydraulically-driven “push” piers. The piers were to penetrate the upper clay soils for bearing within weathered limestone. Four hundred eight (408) Model 288 (2.875-inch OD by 0.276-inch wall) round shaft helical piers were installed along the foundations of the eleven buildings. The 8”-10” double-helix lead section was selected to support the design working load of 18 kips. The helical piers were installed to an average depth of 30 feet and to torque values of at least 4,000 ft-lbs, correlating to ultimate pier capacities of at least 36 kips (FOS ≥ 2). Two hundred eighty (280) Model 288 (2.875-inch OD by 0.165-inch wall) slab piers were installed to an average depth of 25 feet and an average ultimate capacity of 12 kips. Design working loads for the slab piers were generally less than five kips. The slab piers were generally installed in a grid pattern with a spacing of five feet. Following lifting operations of the floor slabs, void space was filled with cement grout injected at low pressure. Due to previous cosmetic repairs that were completed, the foundations were generally lifted less than one inch. The foundations for one building were lifted as much as four inches to recover some of the measured eight inches of differential settlement.

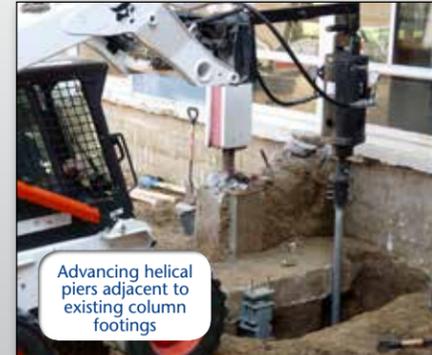
Advancing helical piers adjacent to existing column footings

Solution: Helical piers were selected to provide temporary support for the four columns. The design included 16 piers, four on each column, and each pier to support a design working load of 20 kips. The helical pier configuration consisted of 2.875-inch OD by 0.276-inch wall hollow round shaft with 10”-12”-14” triple-helix lead sections. With their past experience installing helical piers within and through the silty Peoria loess, Foundation Supportworks® by Thrasher anticipated pier depths greater than the depths of the soil borings. The piers were advanced to average depths of 33 feet in order to generate installation torques correlating to ultimate pier capacities of at least 40 kips (FOS ≥ 2). Retrofit brackets were set and the design loads were applied to the piers with hydraulic cylinders.

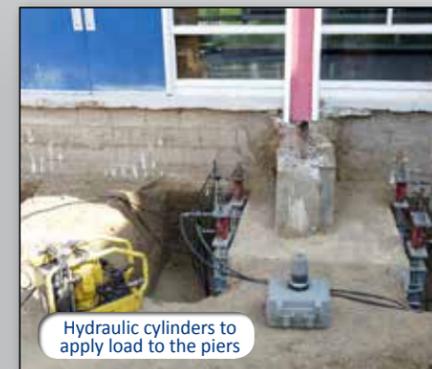
Hydraulic cylinders to apply load to the piers

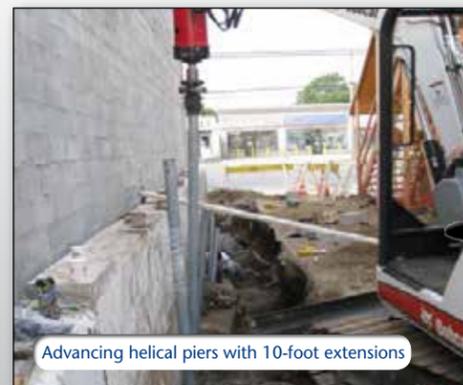
Advancing helical piers with 10-foot extensions

Solution: The retrofit pier design included 11 Model 350 (3.5-inch OD by 0.313-inch wall) helical piers. The new helical pier configuration consisted of 10”-12”-14” quad-helix blade, ten-foot long lead sections. Meticulous site layout was required as the new helical piers would be installed between the existing square bar helical piers and the original timber piles. The leads were installed at a slight angle to allow for the uppermost 14-inch helix blade to extend past the bottom edge of the footing. Once the lead was installed, extensions were added to advance the piers to an average depth of 24.5 feet. The piers were installed to torque-rated ultimate capacities ranging from 60 to 64 kips. Foundation Supportworks® Northeast installed the 11 retrofit helical piers in two days.

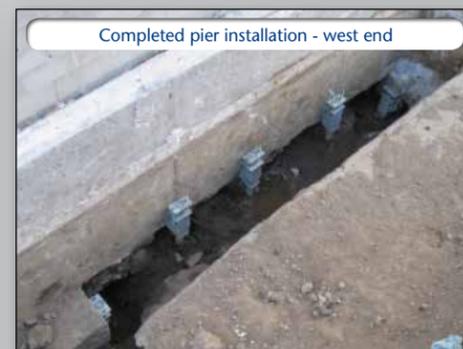
Completed pier installation - west end

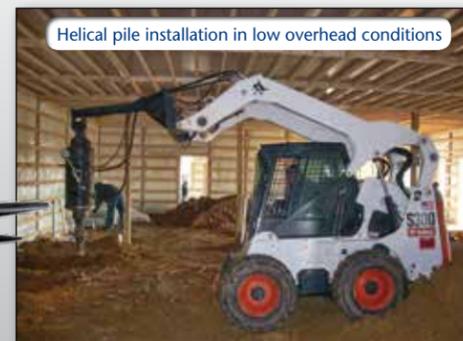
Helical pile installation in low overhead conditions

Solution: The structural settlement was caused by consolidation of the loosely placed fill. One hundred fifty-two (152) helical piers with retrofit brackets were installed to re-support the existing building by extending through the fill to bear within the native medium dense to dense sands or stiff to very stiff clay. The retrofit pier system consisted of the Model 287 (2.875-inch OD by 0.203-inch wall) hollow round shaft with 8”-10”-12” triple-helix lead sections to support a design working load of 15 kips. The retrofit piers were installed to torque-correlated ultimate capacities of at least 30 kips to provide factors of safety (FOS) ≥ 2.0. Hydraulic cylinders were used to lift the foundations to near the original, pre-settlement elevations. Since the concrete floor had not yet been poured, a new structural slab was proposed. The structural slab was supported on 82 new construction helical piers spaced at eight feet center to center in a grid pattern. The helical piers supporting the structural slab consisted of the Model 287 hollow round shaft with 10”-12” double-helix lead sections to support a design working load of 10 kips. The piers were installed to torque-correlated ultimate capacities of at least 20 kips to again provide FOS ≥ 2.0. The retrofit and new construction piers were installed to depths (below bracket bearing elevation) ranging from 22 to 40 feet.

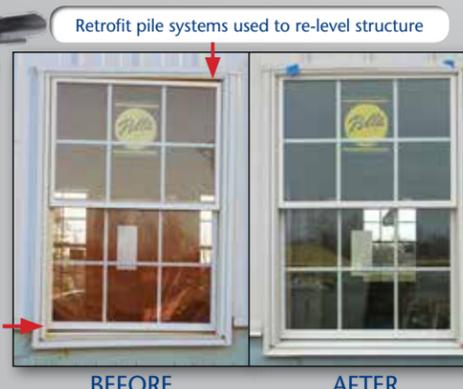
Retrofit pier systems used to re-level structure
