**SUPPORTWORKS**  
FOUNDATION  
Quarterly Newsletter • Issue 5  
Fall/Winter 2010  
FSI NEWSLETTER FOR DESIGN PROFESSIONALS  
**FOUNDATION SUPPORTWORKS**  
For more information about  
Foundation Supportworks,  
please visit our website at  
[www.foundationsupportworks.com](http://www.foundationsupportworks.com)  
or to locate a Foundation Supportworks  
dealer in your area, please visit our website at  
[www.foundationsupportworks.com](http://www.foundationsupportworks.com)  
or call 800.281.8545.

FSI NEWSLETTER FOR DESIGN PROFESSIONALS

## The Difference is in the Details: Coupler Details

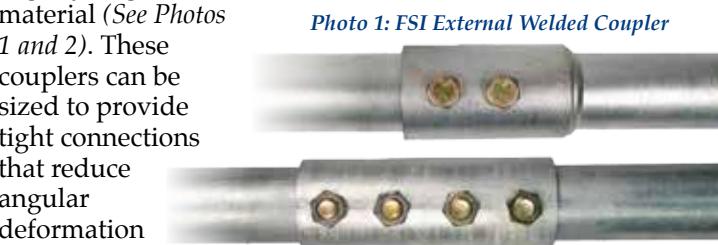
**Photo 1: FSI External Welded Coupler**

**Photo 2: FSI External Detached Coupler**

Some of the more common coupler details for round shaft include external welded, external detached, internal detached, and forged and upset. External couplers utilize tube or pipe sections with an internal diameter slightly larger than the outside diameter of the central shaft material (*See Photos 1 and 2*). These couplers can be sized to provide tight connections that reduce angular deformation and variances from straightness. Such displacements at the couplers introduce eccentricities to the system which can significantly reduce the allowable compressive capacity of the pile, especially considering the slenderness of the more widely used shaft material (typically 3.5-inch outside diameter and smaller).

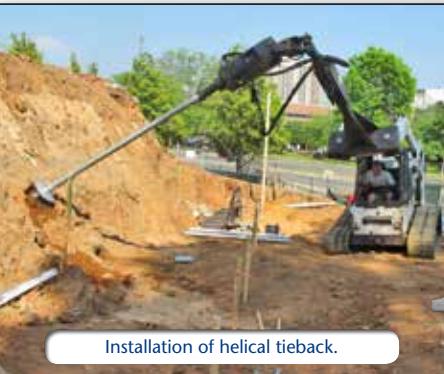
Installation of helical tieback.

**Solution:** A new cast-in-place concrete retaining wall was designed with helical tiebacks to resist the lateral forces. The design included two rows of tiebacks; eleven (11) near the top of the wall with an 8-foot spacing and an installation angle of 30 degrees downward from horizontal, and eighteen (18) near the bottom of the wall with 4, 5, and 6-foot spacings and a horizontal orientation. Design working loads for the angled and horizontal tiebacks were 40 kips and 37.5 kips, respectively. The helical tieback configuration consisted of 3 1/2-inch OD round shaft with 10"-12"-14" triple-helix lead sections. The angled and horizontal tiebacks were installed to torque values of at least 8,600 ft-lb and 8,000 ft-lb, respectively, to provide torque-correlated ultimate capacities of at least 1.5 times the design working loads. Due to the soil variability, the tiebacks were advanced to lengths ranging from 17 to 46 feet in order to achieve the target torque values. The correlation between installation torque and ultimate capacity was verified with two load tests. One retrofit helical pier was also installed to vertically support the footing of an existing block wall against undermining and settlement at the connection to the new wall. The pier configuration consisted of a 2 7/8-inch OD round shaft with a 10"-12" lead section. The pier was installed to a depth of 14 feet and to a torque-correlated ultimate capacity of 30 kips for a factor of safety of 2.

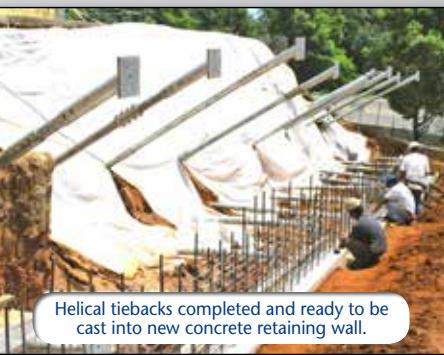
Helical tiebacks completed and ready to be cast into new concrete retaining wall.

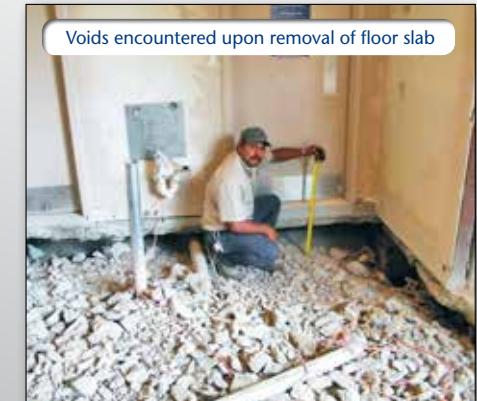
Voids encountered upon removal of floor slab

During the demolition phase of the contract, JES encountered unforeseen conditions in the lobby area and near the main stage. A 10-inch void was encountered beneath the lobby area floor slab and the foundation wall at the stage had settled approximately 1 inch. To resolve these unforeseen conditions, a contract modification was executed to install eighteen (18) hydraulically-driven slab piers in the lobby area and three (3) hydraulically-driven foundation piers at the main stage. The void beneath the pier-supported lobby slab was then filled with cement grout.

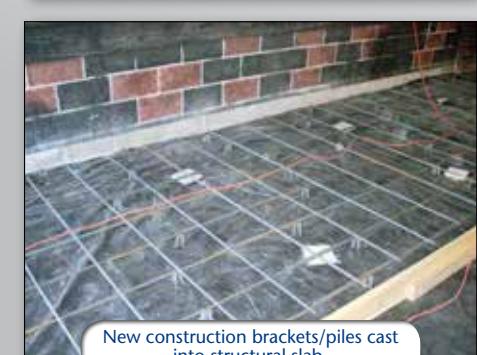
New construction brackets/piles cast into structural slab

**Solution:** JES Construction, Inc. (JES) was awarded the design-build project with the general scope of work to include; partial demolition of the existing concrete slab, installation of helical piles and a new structurally-reinforced concrete slab, construction of a new wheelchair seating area, and incidental carpentry repairs. Fifty-eight (58) helical piles were installed within the 45-foot by 60-foot auditorium. The pile configuration consisted of 2 7/8-inch OD by 0.203-inch wall round shaft with 8"-10" double-helix leads. The helical piles were installed to an average depth of 45 feet to support the design working load of 15 kips. The structural slab was detailed at 5 inches thick (3,000 psi) with No. 4 rebar at 12 inches on center each way and a maximum pile grid spacing of 8 feet.

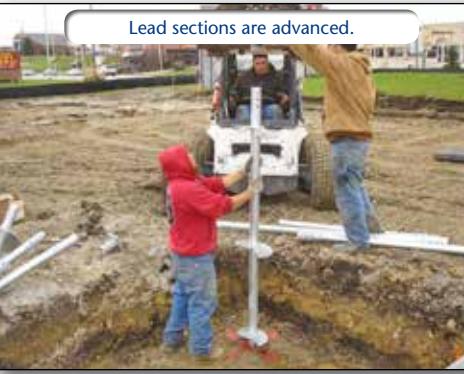
Lead sections are advanced.

**Solution:** Due to scheduling issues and forecasted cold weather conditions, pouring concrete at the site needed to be completed within 13 days from the start of construction. Helical piles became an even more logical solution since foundation concrete can be poured immediately after installation of the piles. Forty-seven (47) Foundation Supportworks Model 288 Helical Piles were specified on the project with allowable capacities of 5, 10, 15, 20 and 25 kips. Three different helical lead configurations were installed to torque values that correlated to the respective capacities, or higher, including a factor of safety of two. Isolated obstructions were encountered within the fill at depths between 10 and 12 feet, but the piles were able to advance through or around this material. Large boulders were also encountered within the first few feet at several locations, requiring removal in order to complete the pile installation. Despite the challenges, the installation of the 47 helical piles was completed in less than three days and the project remained on schedule.

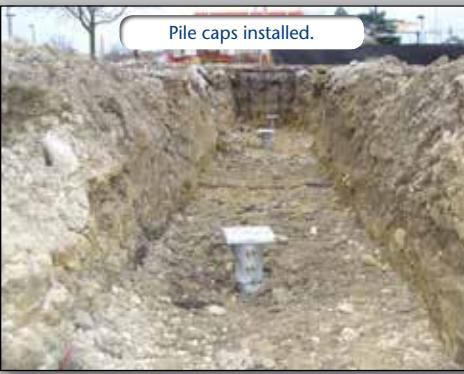
Pile caps installed.

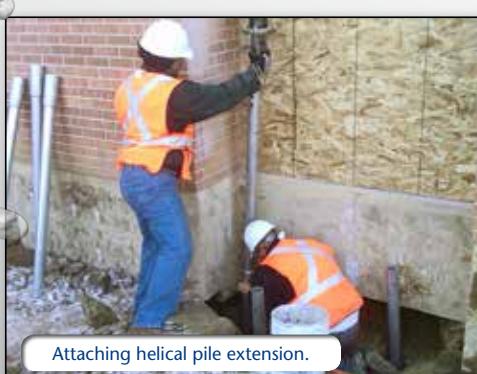
Attaching helical pile extension.

**Solution:** Helical piles were selected to penetrate the upper fill and residual soils for end-bearing within the bedrock. Helical piles proved to be the most cost-effective approach, partly due to the relatively low mobilization costs compared to other deep foundation alternatives. The smaller installation equipment could also access and maneuver more easily within the congested construction site. The foundation design for the new additions included twenty-one new construction helical piles. Twelve retro-fit helical piles were also proposed to support and stabilize the existing structure against further settlement. The helical piles were designed for a working load of 15 tons (30 kips). The helical pile configuration consisted of 2 7/8-inch OD by 0.276-inch wide round shaft with an 8-inch diameter, single-helix lead section. Standard extensions were used to advance the piles to depths ranging from 18 to 23 feet. The pile installation and all related prep and finish work were completed in 4 days and ahead of schedule, even with exterior temperatures reaching negative twelve (-12) degrees Fahrenheit.

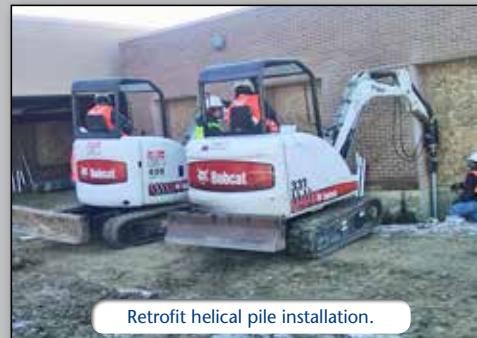
Retrofit helical pile installation.
