CASE STUDY

Helical and Push Piers

Project: Coyle Residence

Location: Sayreville, NJ

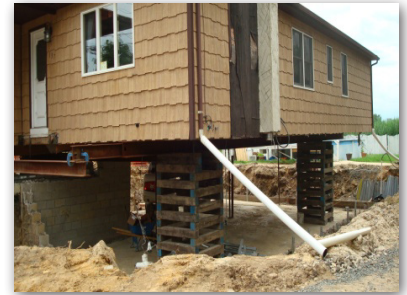
House lifted and original foundation removed

Quality 1st Basement Systems, working with the homeowner's mason, recommended twenty-eight (28) new construction helical piers and eight (8) retrofit push piers to effectively transfer the weight of the home and garage to deep, suitable soils. The house was raised off its original foundation and the footing and foundation wall were removed. Quality 1st Basement Systems then installed the new construction helical piers along the house perimeter to depths of 36 feet. The tops of the helical piers were cast into the new footing/grade beam. To stabilize the sunken footing on the garage wall, eight (8) push piers were hydraulically driven to suitable soils. Quality 1st Basement Systems lifted the garage wall approximately 4" towards a level position. Installation of the new construction helical piers and retrofit push piers were completed within 7 days, despite tight access, difficult working conditions and unforeseen construction delays.
