COMMERCIAL CASE STUDY

Auger Cast Piles

Project: Elevated Pool Deck Project

Location: Clearwater, Florida

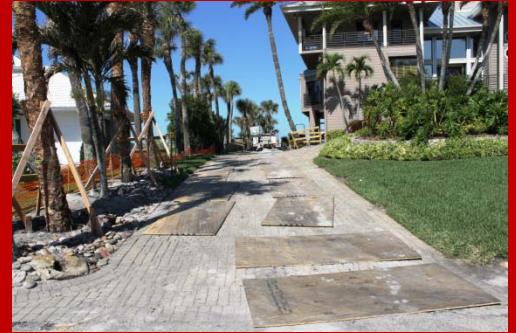
Access was very limited and tight

A property owner on Clearwater Beach wanted to build a pool on an elevated pool structure to enjoy the beachfront view and avoid any potential storm surges that could arise from inclement weather. The property owner wished to replicate the elevated pool concept that was inspired by one of the surrounding property owner's structures. L.R.E., which was hired to install Auger Cast Piles, faced the difficult task of combating limited accessibility and constricted work space while installing a total of 21 piles.

L.R.E. mobilized its Casagrande B175XP Auger Cast rig for this particular project. The Auger Cast piles were needed to provide support, withstand scour and endure coastal weather conditions. The B175XP rig proved to be instrumental in overcoming limited and tight access challenges. While the 16-inch, 35-38 foot piles were not a challenge for the rig, L.R.E. still utilized its *Jean Lutz* Data Acquisition system to provide quality assurance that the perfect pile was installed each time. The final outcome was 21 successful Auger Cast piles with data printouts of each pile and a clean worksite that allowed the general contractor to work on the next phase of the project.

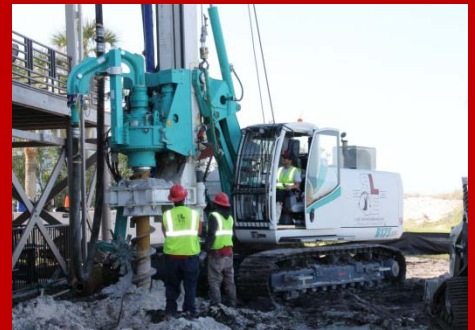
L.R.E. installed 21 Auger Cast piles

Auger Cast Piles: 21 Auger Cast Piles installed to depths between 35 feet and 38 feet. Each pile was 16 inches in diameter and used pile protection tops and single #9 rebar.

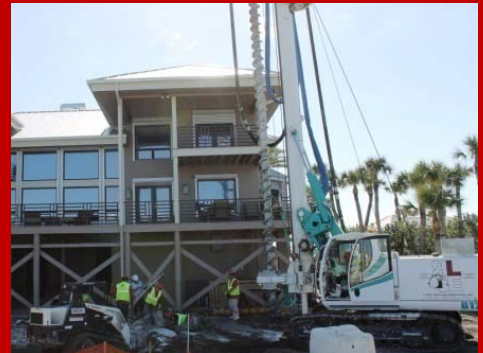
The 21 piles will provide support for an elevated pool structure being built

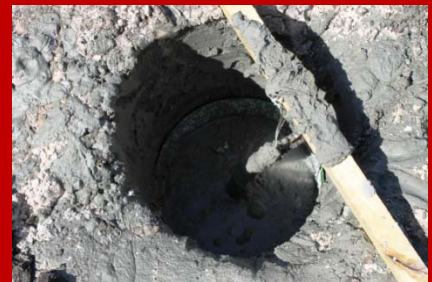
Each pile was 35-38 feet deep and 16 inches in diameter
